Effect of Plate Thickness and Paint on Lightning Strike Damage of Aluminum Alloy Sheet

Takao Okada ¹, Hiromitsu Miyaki ¹, Yoshiyasu Hirano ¹
¹Japan Aerospace Exploration Agency, Tokyo, Japan

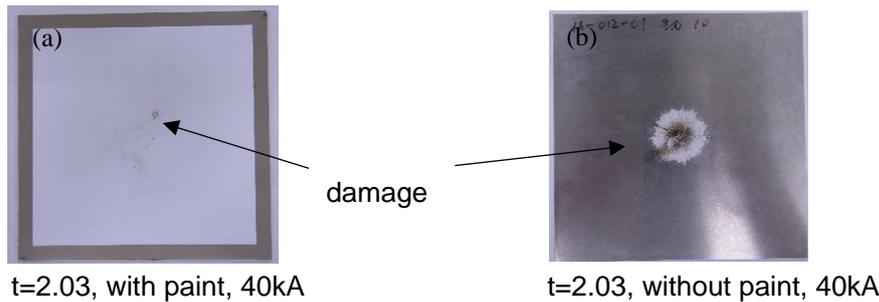
Figure 1. Lightning strike damage on 2024-T3 aluminum alloy. (a) with paint, (b) without paint

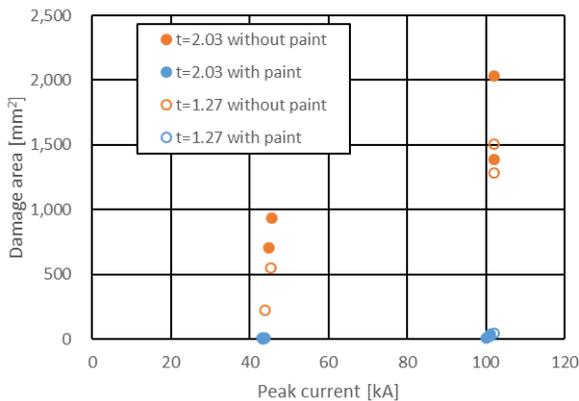
Figure 2. Effect of plate thickness and paint on lightning strike damage
